PHASE I REPORT  
NATIONAL DAM INSPECTION PROGRAM

Name of Dam: BELMONT DAM  
State & State No.: PENNSYLVANIA, 35-33  
County: LACKAWANNA  
Stream: TRIBUTARY TO LACKAWANNA RIVER  
Date of Inspection: May 6, 1980

BELMONT DAM

NDI-ID PA-00252,  
DER-ID 35-33, Susquehanna Fork

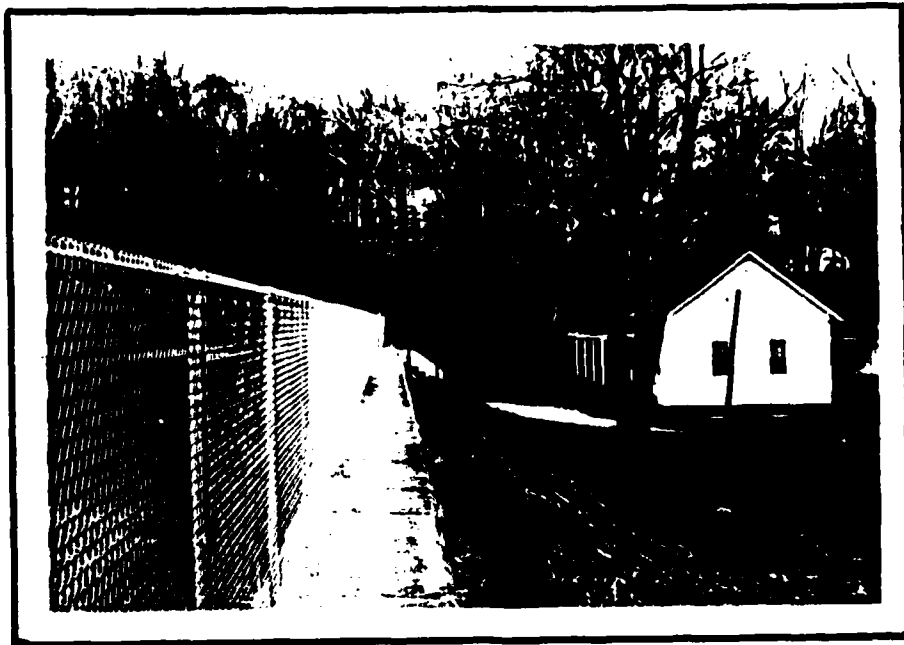
The upstream earthfill embankment is below the normal reservoir water surface elevation. A high chainlink fence on top of the concrete wall (Photographs No. 1 and No. 2) prevented close observation of the upstream side. Riprap appeared to be present on the upstream slope. The crest of the dam is a four foot wide concrete wall. The top of the wall is in good condition, straight and level over its 605 foot length. The downstream side of the wall showed many repair patches. The wall is, however, in good condition.

TOP OF DAM LOOKING TO LEFT ABUTMENT - NO. 2

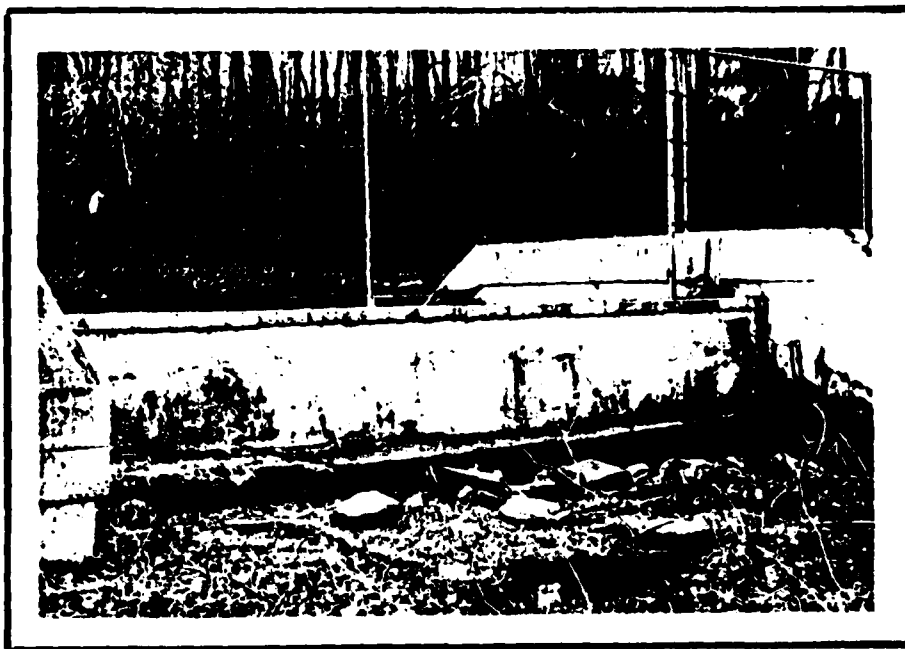
The dam has a concrete masonry spillway near the left abutment. The walls of the spillway are in a deteriorated condition (Photograph No. 6) and the discharge channel immediately below the weir is in such a condition that it is expected that heavy damage would occur if a large discharge would occur (Photograph No. 7). Water was seeping through the rock surface of the channel. The chainlink fence across the spillway reduces the efficiency of the opening.

DOWNSTREAM SIDE OF SPILLWAY - NO. 6

4. That all waste material be removed from the downstream slope and that this slope be provided with an adequate slope protection.
5. That the spillway and discharge channel be repaired if its continued use is contemplated. The chainlink fence on the spillway shall be removed.
